# Service Bulletin

**15-060**

# **Safety Recall: Ignition Coils**

Year	Model	Trim	VIN Range	
2015	Fit	ALL	Check the iN VIN status for eligibility

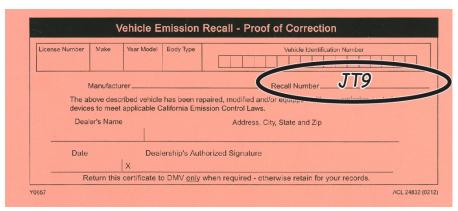
4. Inspect the connection end of the spark plugs.

- If the spark plug connection ends have corrosion on them, clean them with a commercially available cleaner, then reinstall the spark plugs and torque them to 22 N·m (16 lb-ft).
- If the spark plug connection ends does not have any corrosion on them, reinstall the spark plugs and torque them to 22 N·m (16 lb-ft).
- 5. Install the new ignition coils and torque them to 12 N-m (9 lb-ft).
- 6. California residents only: Fill out a Vehicle Emissions Recall Proof of Correction certificate, and use JT9 as the recall number. Give the certificate to your customer, and advise him or her to keep it as proof that the recall was completed. Your customer will need to submit this certificate to the DMV only if the DMV requests it. If you need more certificates, use reorder number Y0657.
